# National Transportation Safety Board

## Marine Accident Brief

### Engine Room Fire on Board Commercial Fishing Vessel *Miss Eva*, with Subsequent Sinking

<b>Accident no.</b>	DCA15LM005
<b>Vessel name</b>	<i>Miss Eva</i>
<b>Accident type</b>	Fire and sinking
<b>Location</b>	Gulf of Mexico, Ship Shoal Block 154, about 35 miles southwest of Grand Isle, Louisiana, 28°40.8' N, 91°12.2' W
<b>Date</b>	December 1, 2014
<b>Time</b>	0708 central standard time (coordinated universal time – 6 hours)
<b>Injuries</b>	Three crewmembers received severe burns, and one crewmember was uninjured
<b>Property damage</b>	Total loss of vessel, estimated at \$550,000
<b>Environmental damage</b>	No sheen was reported from the estimated 3,200 gallons of marine diesel fuel and 100 gallons of hydraulic oil on board
<b>Weather</b>	Clear skies, visibility 6.5 miles,* winds from the east-southeast at 10 knots, seas 1 to 2 feet
<b>Waterway information</b>	Gulf of Mexico, open water

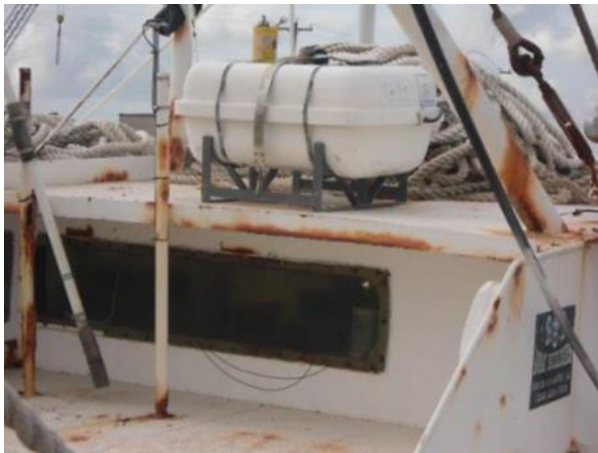
While the deckhand was in the process of manually releasing the six-person liferaft located above the wheelhouse, a second explosion occurred that blew out the wheelhouse windows. The deckhand tossed the liferaft canister over the starboard side and inflated the raft. Flames and smoke exited the location where the wheelhouse windows had been, so the deckhand jumped into the water from the roof of the wheelhouse. He received burns to 6 percent of his body, including his upper extremities and back. The deckhand then righted the liferaft and entered it followed by the junior deckhand, who had been clinging to the fishing rigging. Afterward, the senior deckhand and then the master jumped into the water and entered the liferaft. None of the crewmembers retrieved lifejackets or the vessel's emergency position indicating radio beacon (EPIRB) before entering the liferaft.

The left photo shows the *Miss Eva*'s liferaft located above the wheelhouse. (Photo by K.W. Diers)  
The right photo shows the *Miss Eva* on fire with an Era helicopter circling the liferaft and the vessel. (Image from video by Chad Guidroz)
